## Environmental protection, health, and occupational safety initiatives: Reducing filter waste and environmental contamination from oil leaks in coal mining excavators

World Journal of Advanced Research and Reviews, 2024, 24(01), 2509–2520

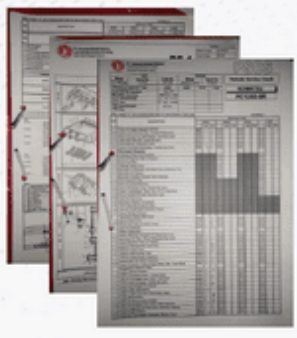
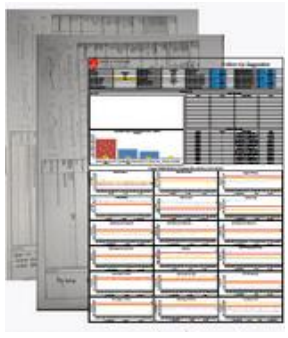
No	Alternative Solutions	Before	After	Impact
1	Develop a standardized form for follow-up suggestions

All follow-ups are documented more thoroughly and effectively
2	Establish a dedicated group for managing health equipment

In Table 3, three solutions are proposed to address the issue of follow-up coordination related to the receptacle, which had not been previously handled. The first solution involves the creation of a standard form for unit health follow-up, as there had previously been no formal documentation for this process. After implementation, a standard form was introduced, containing detailed information on the unit's health and specific suggestions to address the problems that occurred. The second solution entails forming a dedicated group for equipment health, allowing for more focused and detailed discussions, in contrast to broader conversations in larger groups. The third solution incorporates discussions on future tasks during daily meetings. These meetings now not only review breakdown statuses for the current day but also include plans for up to two days ahead. This ensures better preparation of parts, support tools, and manpower, allowing follow-up activities to be executed effectively and efficiently. The second issue relates to hydraulic system leaks, primarily caused by a blocked radiator and high ambient temperatures, which averaged around 60°C. The solution implemented to tackle this problem involves washing and cleaning the radiator every 6000 hours using a removal method. This strategy has proven effective, as the operating temperature returned to normal levels. Additionally, the fan speed was increased electrically to stabilize the surrounding temperature, helping to further prevent hydraulic system leaks.

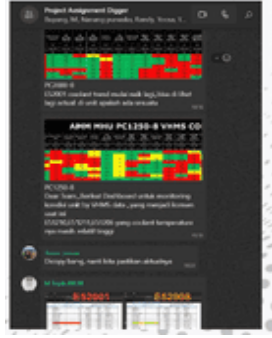
All follow-ups are completed with improved and comprehensive documentation
