## Coastal erosion investigation using electrical resistivity and remote sensing along the coastline of Bayelsa State, Nigeria

World Journal of Advanced Research and Reviews, 2026, 30(02), 316-324

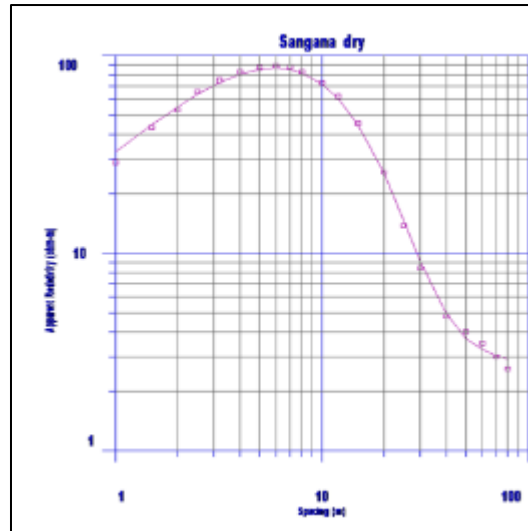
Figure 2 Sangana 1

**Table 1** Sangana 1

| Resistivity | Thickness | Depth | Error |
| 19.230 | 0.52890 | 0.52890 | 4.4924 |
| 233.81 | 1.4922 | 2.0211 | |
| 97.099 | 2.4731 | 4.4941 | |
| 6.5765 | 11.248 | 15.742 | |
| 2.6579 | | | |

From the VES results of locations of Sangana and Okuru communities, the top soils are close to being similar because the variation of resistivities of the top soils of the two locations can be considered to be small. It is, therefore, considered that the two areas have similar top soils though negligible variations of resistivity values. The location of Okuru is very close to Koluama community just like Sangana community. In essence, Sangana, Koluama and Okuru communities are having similar topsoils.

The resistivity values of Figs 1, 2 and 3, the soil particles are of more finer sandy material and loose than those of Fig 4 and 5 which are of higher values of resistivity. The soil of Figs 1, 2, and 3 can be more eroded than those of Fig 4 and 5.

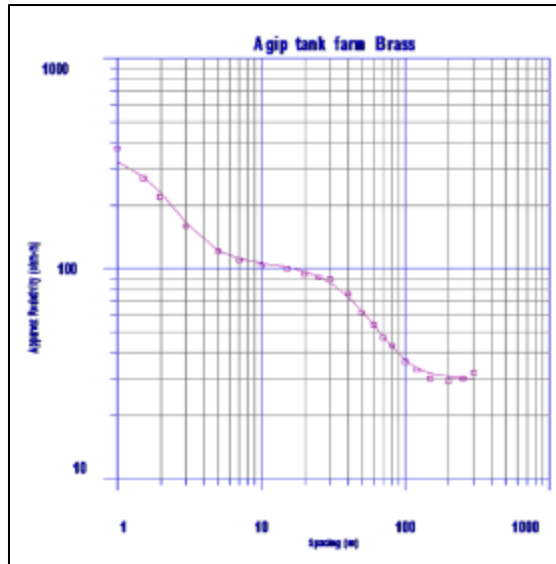
Figure 5 Brass 1

**Table 4** Brass 1

| Resistivity | Thickness | Depth | Error |
| 359.86 | 0.95252 | 0.95252 | 4.4461 |
| 106.23 | 6.2400 | 7.1926 | |
| 100.15 | 17.188 | 24.380 | |
| 28.497 | 48.408 | 72.788 | |
| 29.763 | | | |

On the contrary, Brass is having a comparatively higher values of resistivity of the top soil. These higher values of the resistivity could mean a lot of soil properties such as presence of inorganic compounds, traces of hydrocarbon, compaction or stony material. This is where the importance of groundtruthing comes to play. At the time when this study was conducted there was no trace of crude oil or hydrocarbon or other inorganic materials at or close to the site of the survey. The results are, therefore, limited to the characteristics of the soil. The top soil of Brass (Twon) is a bit different from that of Sangana and Koluama where the erosional activities are more serious.

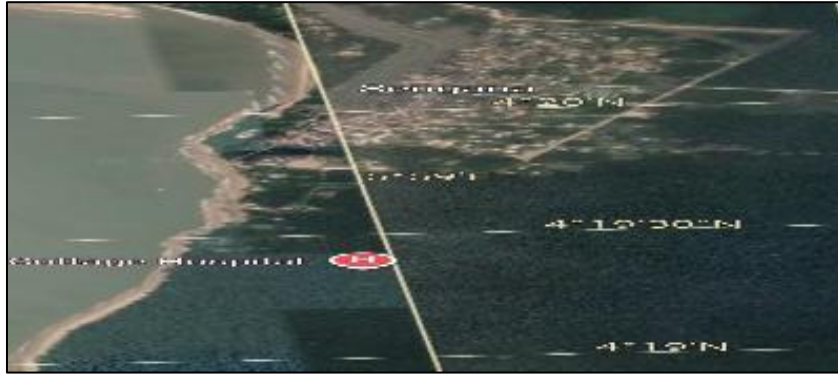
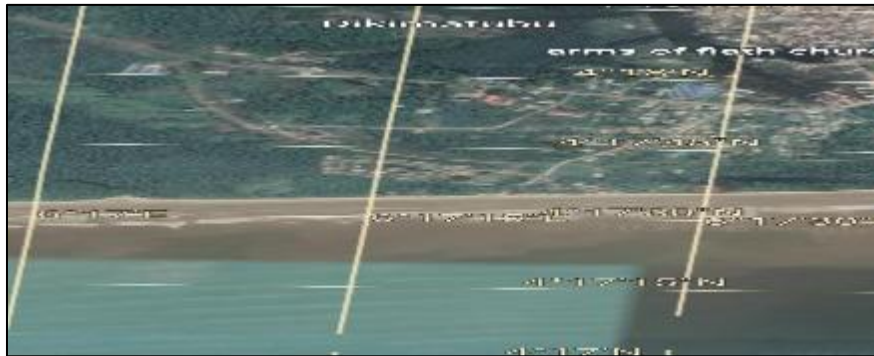
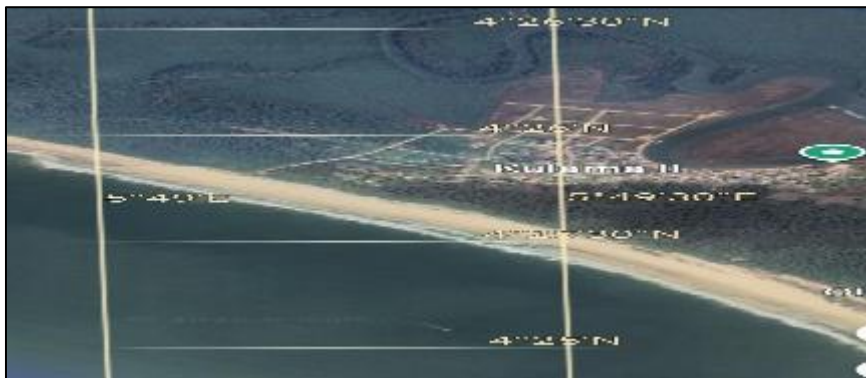
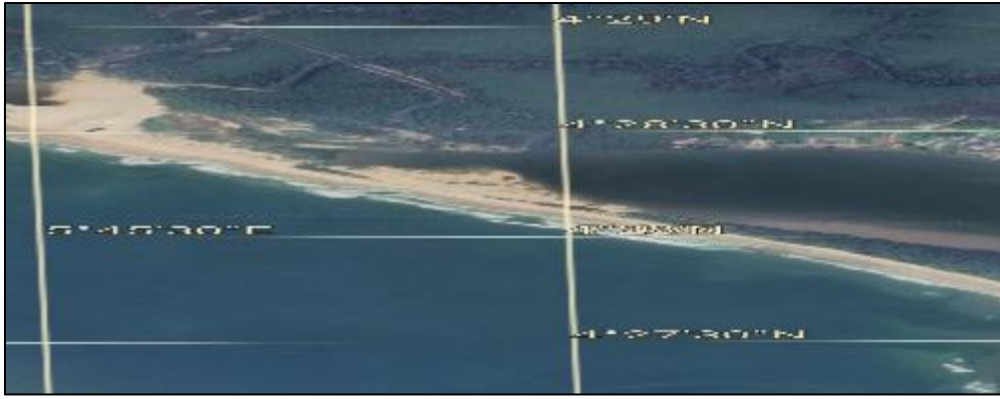
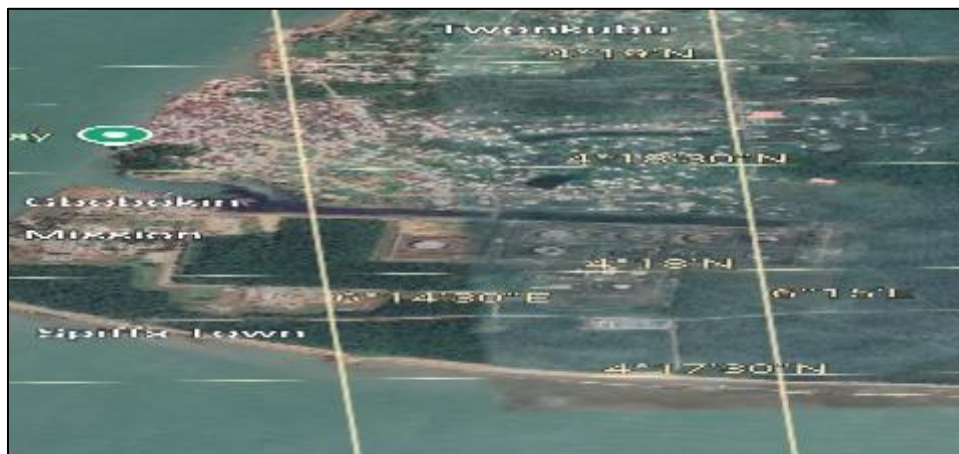
The area of study is made up of mangrove forest. From Figs 7,8,9,10 and 12 along the shoreline, vegetative cover is sparse in areas such as koluama 2, koluama 1, Sangana, Brass Island and others. This sparse nature of vegetation is attributable to previous oil spill which occurred in the past particularly at koluama and Sangana area. It is , therefore, identified that erosion may persist due to lack of protection from vegetation as noted form the various figures. However, in Fig11, there is enough vegetative cover and the community (Egwema) is situated from some distance away from the shore not like other communities noted.
