## Evaluation of the severity of flood impact on building structures and fabrics in Anambra West Local Government Area, Anambra State, Nigeria

World Journal of Advanced Research and Reviews, 2026, 30(03), 428-435

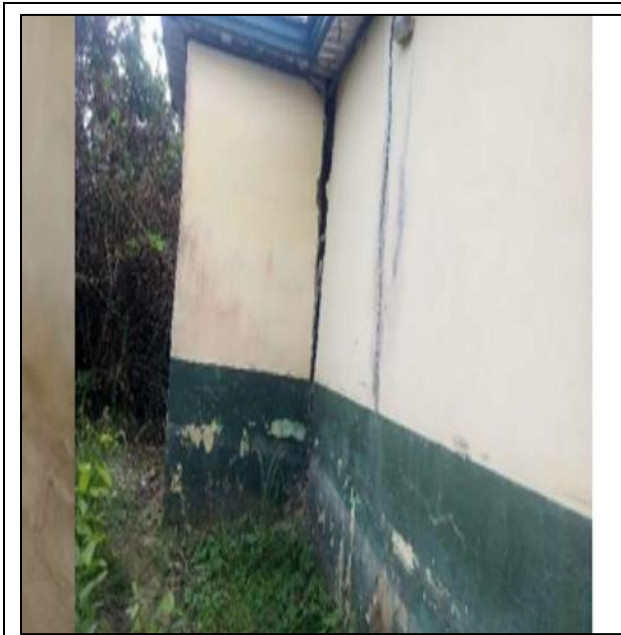
**Figure 2** Damage to building fabrics and finishes

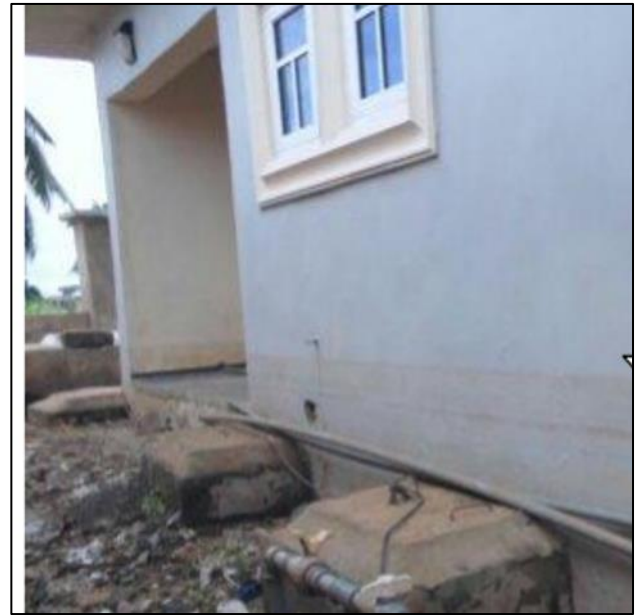
**Figure 3** Aesthetic discolouring

The findings revealed that aesthetic discolouring (mean = 4.66) was the most severe impact of flooding on buildings in Anambra West, indicating that floodwaters leave significant staining on tiles, paints, and wall finishes (see Figure 3). Submerging of buildings (mean = 4.63) ranked second, confirming that floodwaters routinely inundate buildings in the study area (see Figure 4). Deterioration and degradation of building components (mean = 4.59) and contamination of buildings (mean = 4.56) followed closely, demonstrating that flood borne substances compromise building materials and introduce contaminants. Structural damage/cracks recorded a mean of 4.50, consistent with Edoka, Idris and Anozie (2024), which found that flooding causes foundation, floor, and wall cracks (see Figure 2). Disruption of serviceability and operation (mean = 4.48) aligns with Adetunji and Oyeleye (2018), who noted that flood hazards disrupt building serviceability when water depth impedes access. Inflow to sewage (mean = 4.06) confirms Efobi and Anierobi's (2013) observation that flooding causes sewage system contamination. Notably, building collapse recorded the lowest mean (2.58), suggesting that while flooding severely damages buildings, complete collapse is rare in Anambra West. This finding diverges from Okunbiri and Puyate (2023), who reported building collapse in other flood-prone areas, possibly due to the predominance of elevated storey buildings with reinforced concrete construction in the study area. The one-sample t-test confirmed that all eight flood impact items were statistically significant ( $p < 0.05$ ), leading to rejection of the null hypothesis that flooding does not have significant impact on building components. The overall

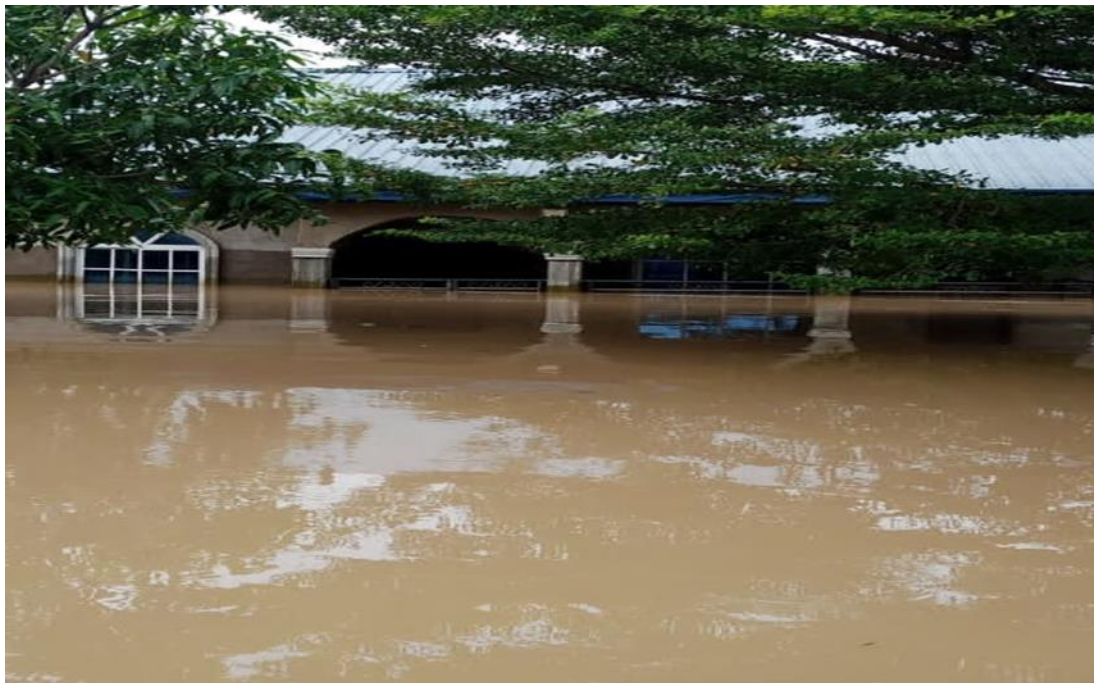
**Figure 4** Submergence, disruption of the operation and serviceability of the building
