## IDENTIFICATION AND ESTIMATION OF WATER LOSSES ALONG THE HEAD REACH OF THE MAIN CANAL OF THE BAGUINÉDA IRRIGATION SCHEME (OPIB, MALI): THE CASE OF UNAUTHORIZED OFFTAKES

World Journal of Advanced Research and Reviews, 2026, 32(01), 040–052

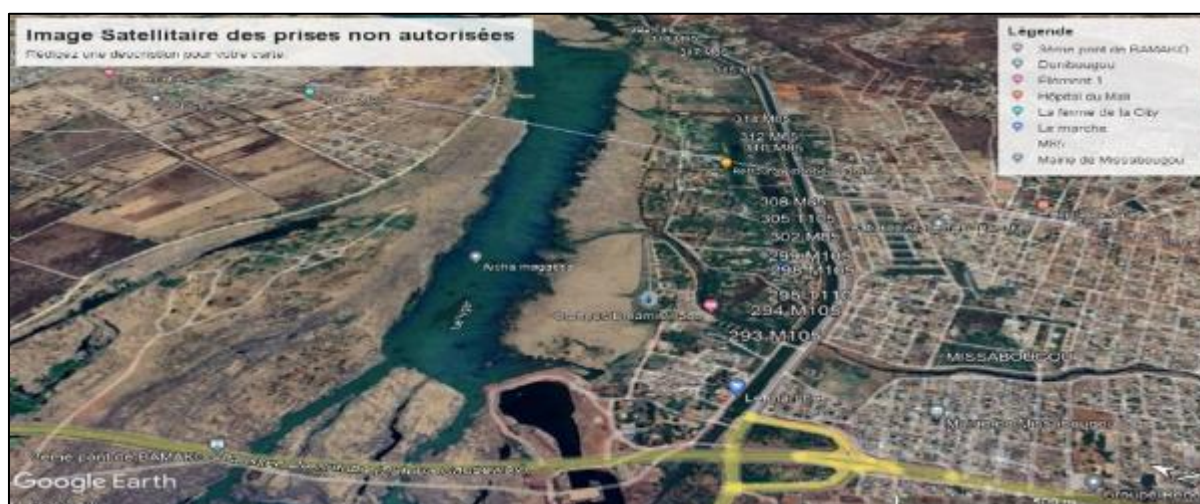
Figure 2: Satellite image of unauthorized offtakes downstream of the third bridge of Bamako

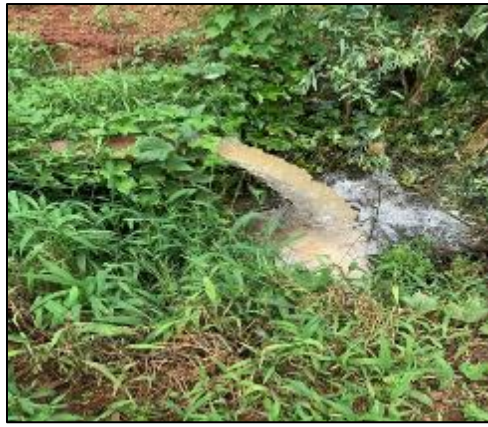
In addition to motor pumps, unauthorized offtakes generally consist of PVC or metal pipes of various diameters buried in the canal embankment, without any upstream control device. Their discharge depends on the water head in the canal (4).

**Figure 3: Pipe**

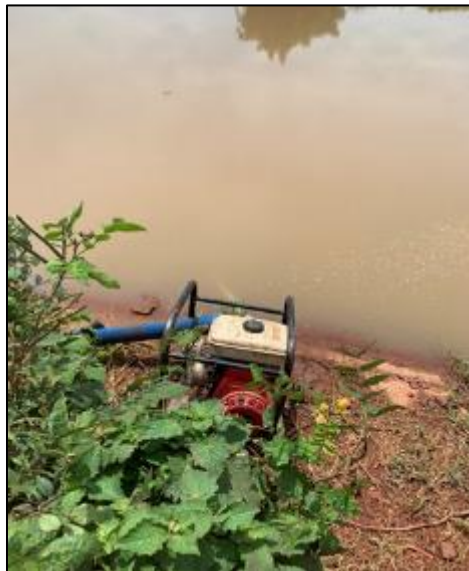
The motor pumps inventoried along the head reach withdraw water through pipework whose diameter was measured in the field.

**Figure 4: Motor pump**
